Tech Talk

Fine Lines in High Yield (Part CXXXViii)

More on Copper Whiskers

Karl H. Dietz (for CircuiTree Magazine, March, 2007)

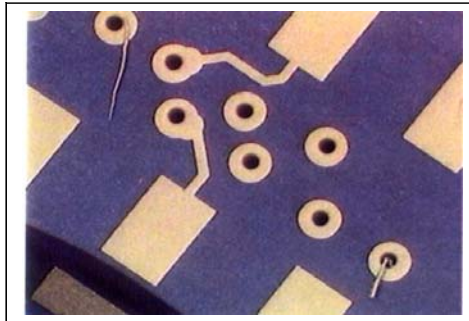
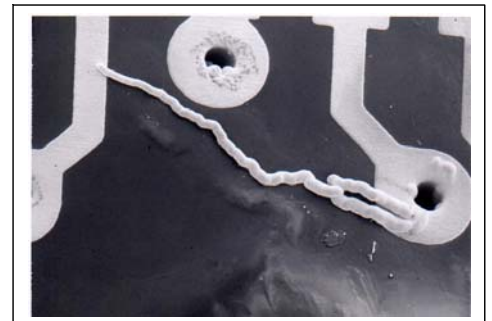
Figures 1 & 2: Illustrations of Copper Whiskers

Copper whiskers are ugly filaments that form during copper electroplating and can obviously lead to defects such as space violations and shorts (see Figures 1 and 2).

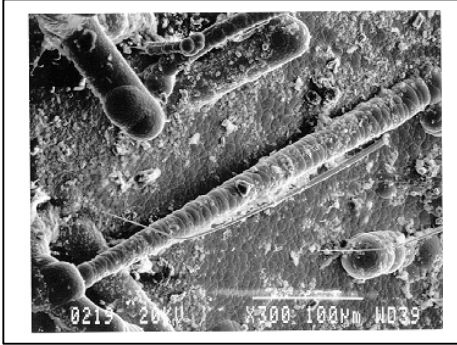
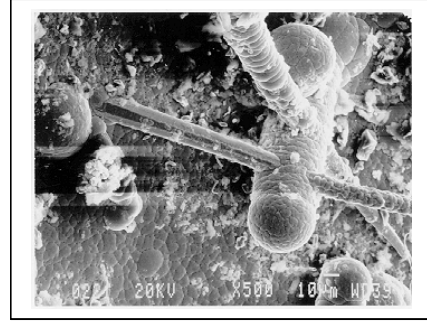
In a different incident, after examining SEMs and optical microscope pictures of the plating defects (see Fig. 3-6), the plating trouble-shooter came to the conclusion that he had a bad case of "stringy nodules". These stringy nodules were postulated to occur when a biological growth is introduced to the copper plating bath from an outside source. The growth is killed by the copper sulfate, the growth carcass becomes impregnated with copper sulfate, becomes conductive, and is deposited on the board surface along with standard copper deposition. These nodules can take on many shapes: filament-like, a tangled mess, even undulating through the deposited surface copper.

Figures 3 & 4: SEMs of "Stringy Nodules"

If the phenomenon is caused by biological growth, the immediate fix is improved house keeping. Rinses must be dumped and sanitized (usually with either bleach or peroxide). Brightener feed tanks need to be sanitized and feed lines are best replaced. Cleaner and etch tanks may also need to be rebuilt. Copper tanks need to be micro-filtered, preferably into separate tanks so that the entire solution passes through the filter medium. This is an opportune time to carbon treat, since many work hours are committed to the bath clean-up, and the carbon filter pack removes extremely fine particles.

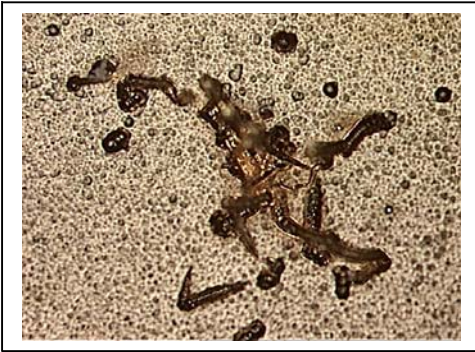
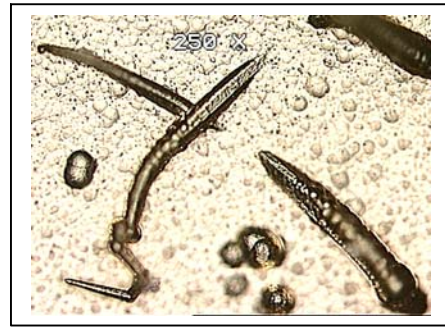
Figures 5 & 6: Optical Microscope Pictures of "Stringy Nodules"
