Tech Talk

Fine Lines in High Yield (Part CXXIX) Copper Whiskers

Karl H. Dietz (for CircuiTree Magazine, June, 2006)

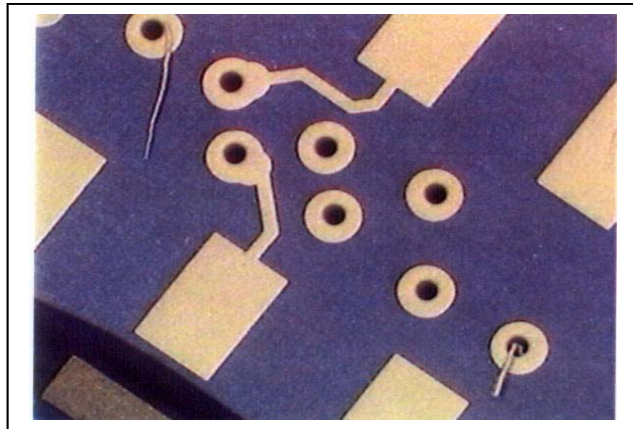
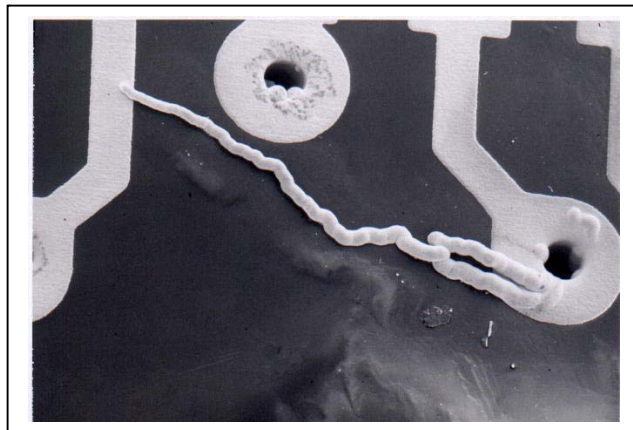
Copper whiskers are ugly filaments that form during copper electroplating and can obviously lead to defects such as space violations and shorts (see Figures 1 and 2).

Figures 1 & 2: Illustrations of Copper Whiskers
