Tech Talk

Fine Lines in High Yield (Part CLVI)

Defect Problems & Defect Prevention in Development

Karl H. Dietz (for CircuiTree Magazine, September, 2008)

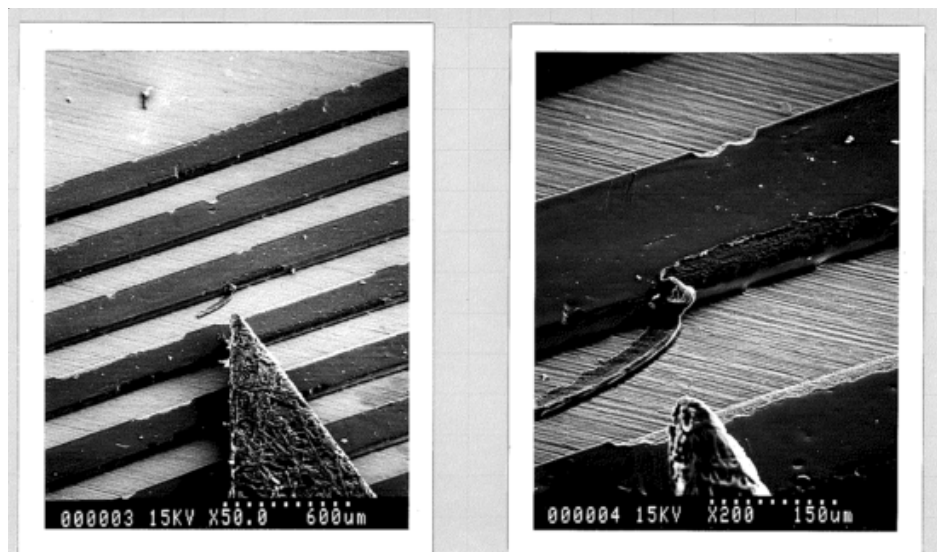
One nagging defect called resist "slivers" resurfaces off and on. It is a defect characterized by the fact the "nose" of the resist, i.e. the resist edge at the corner between the sidewall and the top surface of the resist, breaks off during development. Such a sliver can then deposit on the copper surface between two resist lines. This may not necessarily lead to a defect such as a short in a print-and-etch process, if the sliver is small and narrow enough and if the process is set up to over-etch slightly in order to form straighter copper sidewalls. But if the sliver is large enough, it can lead to a short. In a plating process it can lead to poor plating or no plating in the location of the sliver. It has been known that the origin of such slivers is the resist nose because occasionally one can see such a sliver still attached to the resist from where it broke off (see Fig. 1 & 2).

Figures 1 & 2: Resist Sliver, Still Attached to the Resist Trace.

The formation of slivers has been associated with over-development, i.e. any condition that causes excessive attack of the developer chemistry on the resist such as early break-point, high carbonate concentration, or high developer temperature. Even if the break-point is correct but is achieved by a long dwell time (slow conveyor speed) in the development chamber, there can be a problem. The mechanism of the sliver formation is not well understood, at least I don't have a really good explanation. However, it is generally assumed that the resist swells more than it does under better controlled development conditions. Swelling is most prominent at the resist nose because the nose is exposed to the developer solution from two sides. If swelling is diffusion controlled, then the nose is most exposed to the diffusing developer solution. It will swell first, and more so than the bulk resist, causing stress between the bulk resist and the resist nose. The impact of developer sprays, especially from fan nozzles, can then knock off the nose and form the sliver. Several observations support these explanations. Photoresists that are more hydrophilic, i.e. more prone to swelling, are more likely to cause slivers. Secondly, reducing the spray pressure has been shown to reduce sliver defects. And going to milder development conditions generally helps reduce these defects.

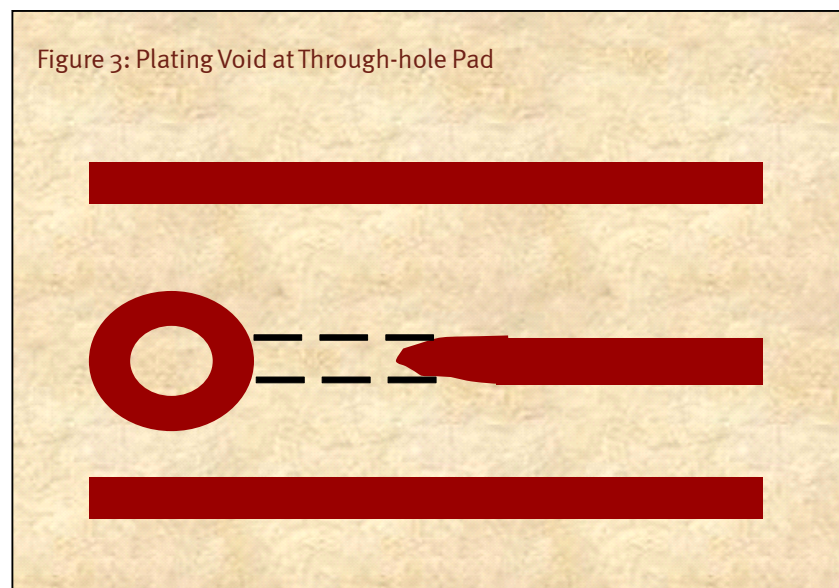
Another unique defect has been observed (see Fig. 3). The defect is a neck-down or cut of a plated line near the pad of a plated through-hole. Plated lines adjacent to the defective line are perfect, the cut is only seen at the line leading to a through-hole. The defect occurs more often with smaller diameter, high aspect ratio holes. Troubleshooting efforts finally led to the root cause, namely poor developer rinse and drying (see also Ref. 3). Developer solution remaining in the hole was not removed by the developer rinse. The trapped developer solution then bled onto the pad and copper trace connecting to the pad and prevented plating in this area. When the rinse capacity was increased and drying improved, the problem went away.
