# Tech Talk

## Fine Lines in High Yield (Part CXLIX)

### Opens and Shorts

Karl H. Dietz (for CircuiTree Magazine, February, 2008)

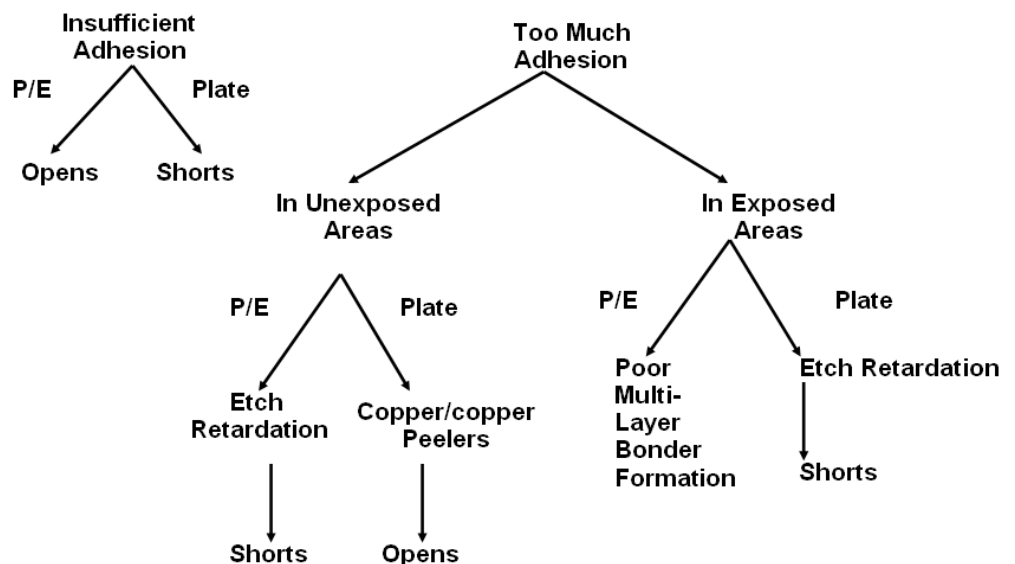
Figure 1: Failure Modes due to Insufficient or Excessive Resist Adhesion

Since conductors are formed by etching, or plating, or a combination of plating and etching, any obstruction to etching may lead to shorts or near-shorts, and any lack of cover or protection of surface areas that should not be etched can lead to opens or near-opens. Likewise, if plating is obstructed it can lead to opens or near-opens, and if plating happens in non-plating areas it can lead to shorts or near-shorts. If these problems are associated with the photoresist process, one can map out the different problem scenarios that have to do with insufficient or excessive resist adhesion as shown in Figure 1.

The failure mechanisms due to "Insufficient Adhesion" are pretty obvious: in the print & etch (P&E) process there is the danger of under-etching the resist which will lead to opens or near-opens such as mouse bites or dish-downs. In the plating process there is the possibility of under-plating so that after copper plating, metal etch resist plating and resist stripping, we have to etch through more copper where under-plating occurred, and since the etching process has been set up in such a way that there is just enough etching to remove the base copper and the thin electroless copper, there will not be enough time in the etcher to remove the excessive copper thickness in the under-plated area.

The failure mechanisms due to "Too Much Adhesion" are more complex as is evident from Figure 1. One has to distinguish between too much adhesion in unexposed areas and too much adhesion in exposed areas. Too much adhesion in unexposed areas in the P&E process will leave development residues on top of the copper that is to be etched. This can lead to etch retardation which in turn can lead to shorts or near-shorts. Too much adhesion in unexposed areas in the plating process can leave resist residues in the area where plating should occur. Such residues may impede plating altogether or, if plating occurs, the resist residues don't allow the plated copper to bond tightly to the base copper which may lead to copper/copper peelers, and ultimately to opens. If there is too much adhesion in the exposed resist areas, this may lead to resist residues in the P&E process after stripping on top of the copper circuit which can interfere with the application of the multilayer bonder treatment which in turn may lead to lamination defects. If there is too much adhesion of the exposed resist in the plating process, there may be resist residues after stripping in areas that should be etched which can lead to etch retardation and shorts between plated lines.
